## Spontaneous Fracture and Vaginal Expulsion of the Arm of Intra-Uterine Device: Case Report

Rahim İçi Araç Kırılması / Fracture of Intrauterine Device

Received: 02.10.2015 Accepted: 05.10.2015 Printed: 01.12.2015 J Clin Anal Med 2015;6(suppl 6): 880-2

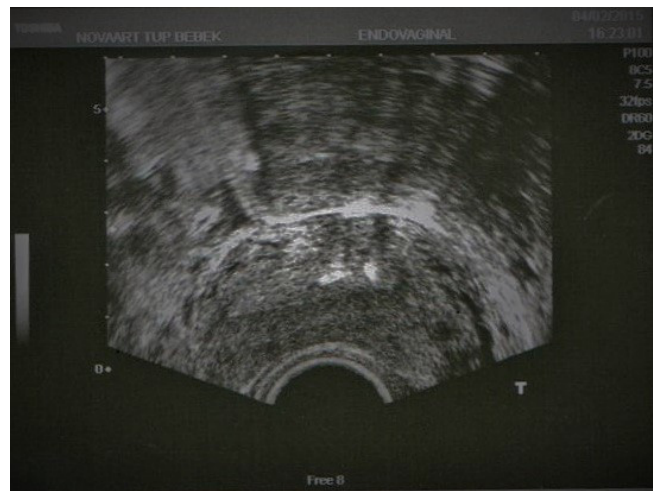
Fig I. Absence of the left arm echogenicity

A 30 years old patient who gave her first birth by cesarean section 2 years ago recurred to our clinic due to finding of a foreign body at her vagina outlet. The foreign body was determined to be a piece of copper IUD. Copper IUD (Copper T380A) was inserted in the postpartum 2nd month easily, without any complication. It was in its place at the controls in the 3rd and 18th months. The patient complained from blot hemorrhage for 20 days and pelvic pain for 2 days. During the gynecologic examination the string of IUD was seen and minimal blood was observed in cervical ostium. In TVUSG examination, copper IUD was seen as dislocated. Left transverse arm echogenicity was not identified in transvers section (Fig. I). It was found out that copper IUD has broken at the joint of left transverse arm and vertical body. It was removed easily by pulling the string. Additional intervention was not necessitated because the broken piece and the piece taken out had complemented each other and echogenicity dependent to copper IUD was not identified at control TVUSG (Fig. II).

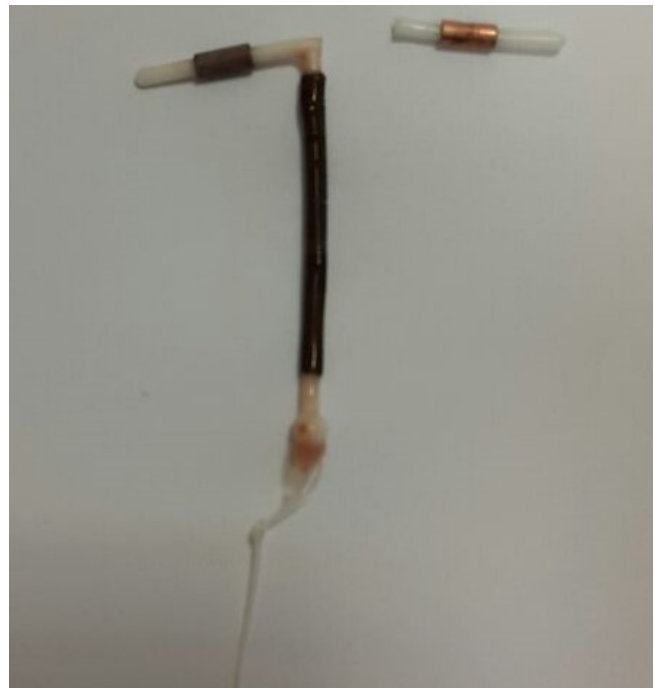
Fig II. Broken and removed part of IUCD

manufacturing defects are considered being responsible from breakage of IUD [6]. To understand fracture mechanisms, force imposed to different IUD types during the insertion, removal and breakage are measured [6, 7]. According to the results of these measurements, a force of 1.5-4 N and 5-6 N is needed for an easy IUD placement and removal, respectively. However for the breakage of IUD 15-22 N force is needed [6, 8]. Moreover it was shown that, as the time period in uterus is extended, the pressure for breakage gets lower [9]. Because uterus can create 20 N magnitude force, uterine forces seems to be more effective factor on fracture mechanism than the forces applied during routine IUD insertion and removal [6, 8]. In fact most of the fractures identified during removal might occur previously. Unless routine ultrasonography is performed before removal or continuity of IUD echogenicity is examined carefully, intrauterine fractures can be overlooked. In our case, if the broken piece had not been expelled spontaneously and it had not been realized by the patient, it could be perceived as broken during removal.
